ILCHALAI RESTORATION PROJECT

Bunds and Stone Lines

JUSTDIGGIT
COOLING DOWN THE PLANET

[6 July 2022]

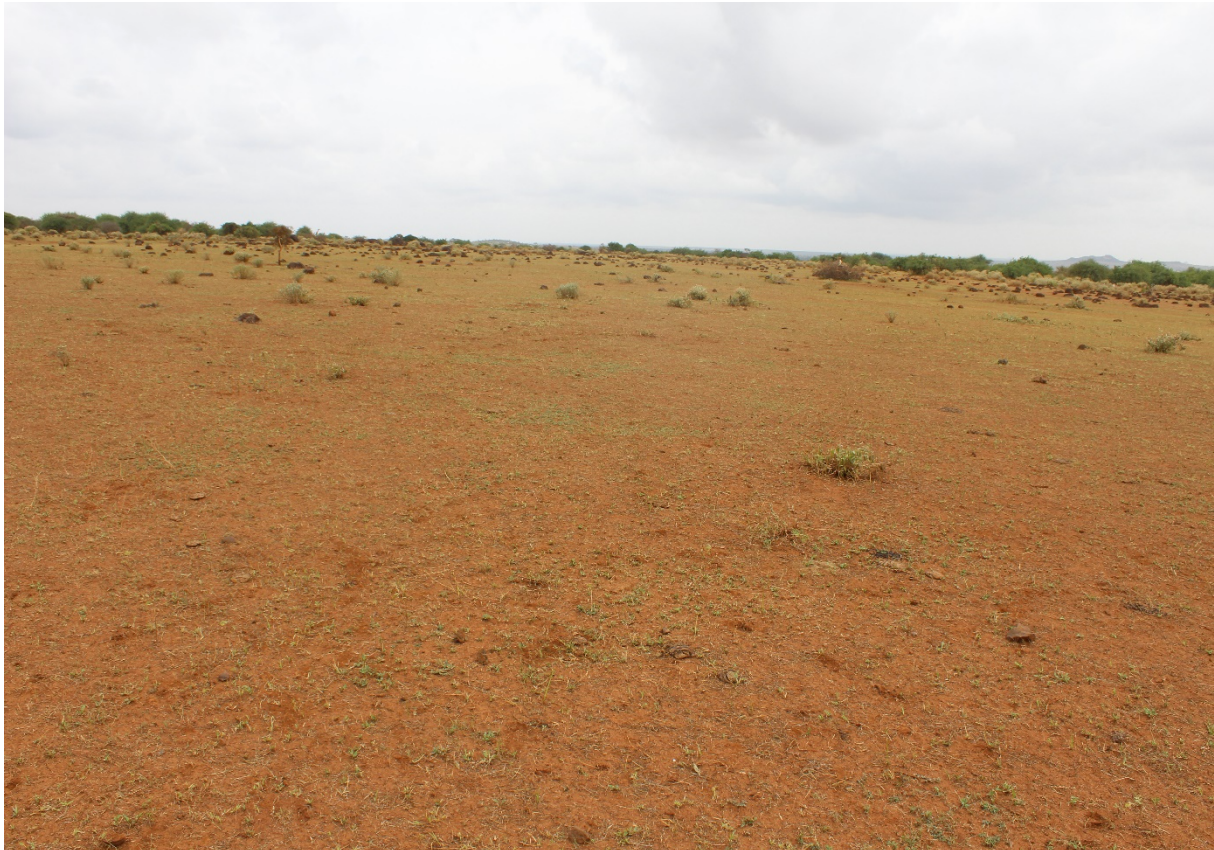
The Ilchalai area was highly degraded, with only sparse annual, low quality grasses present. The disadvantage of these annual grasses is that very shortly after the rains have stopped, they dry up, and they are also not of significant value to the livestock of the Maasai people. The land is not able to retain water, leading to a lot of surface runoff and thereby erosion when it rains. This has also led to the formation of gullies in the surrounding area. The Ilchalai area was deemed a good site for intensive restoration interventions, through water harvesting interventions such as the semi-circular soil bunds and stone lines in order to slow down water, and aid in the healing of the starting gullies.

Figure 1: Project site prior to project implementation

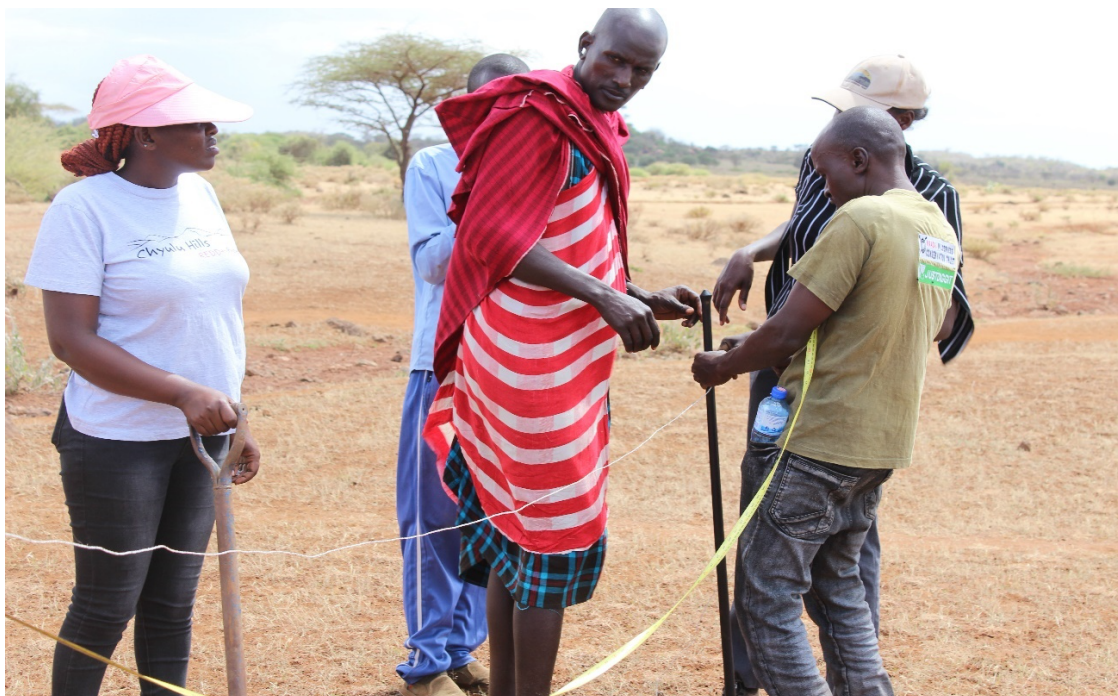
Figure 3: Bund measurement and drawing training with the technical team in Ilchalai

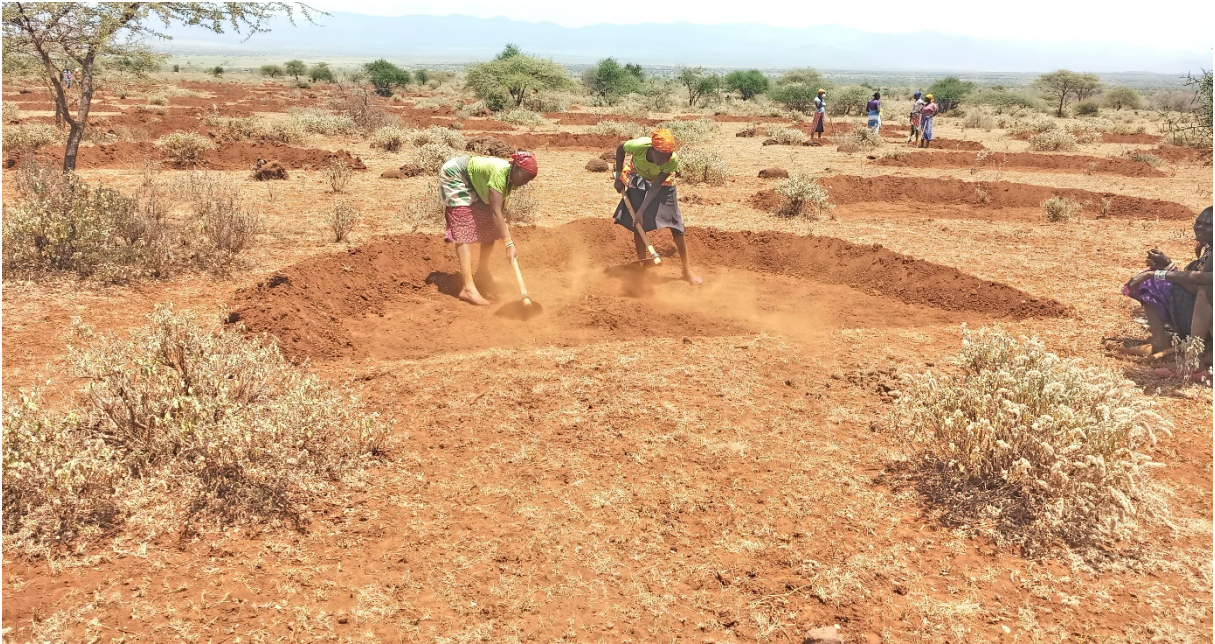
After the training, the digging of the bunds commenced. For the first three days we had 80 diggers on the ground who each dug three bunds. The slow start was planned so that we can manage the quality of the bunds while the diggers were still getting familiar with the work and technique. On the subsequent days to the end of the project, we had 100 diggers, digging 6 bunds every day, and working 6 days a week. We also had 10 fundis, one head fundi and 6 technical team members on the ground each day.

Figure 4: Bund digging in Ilchalai

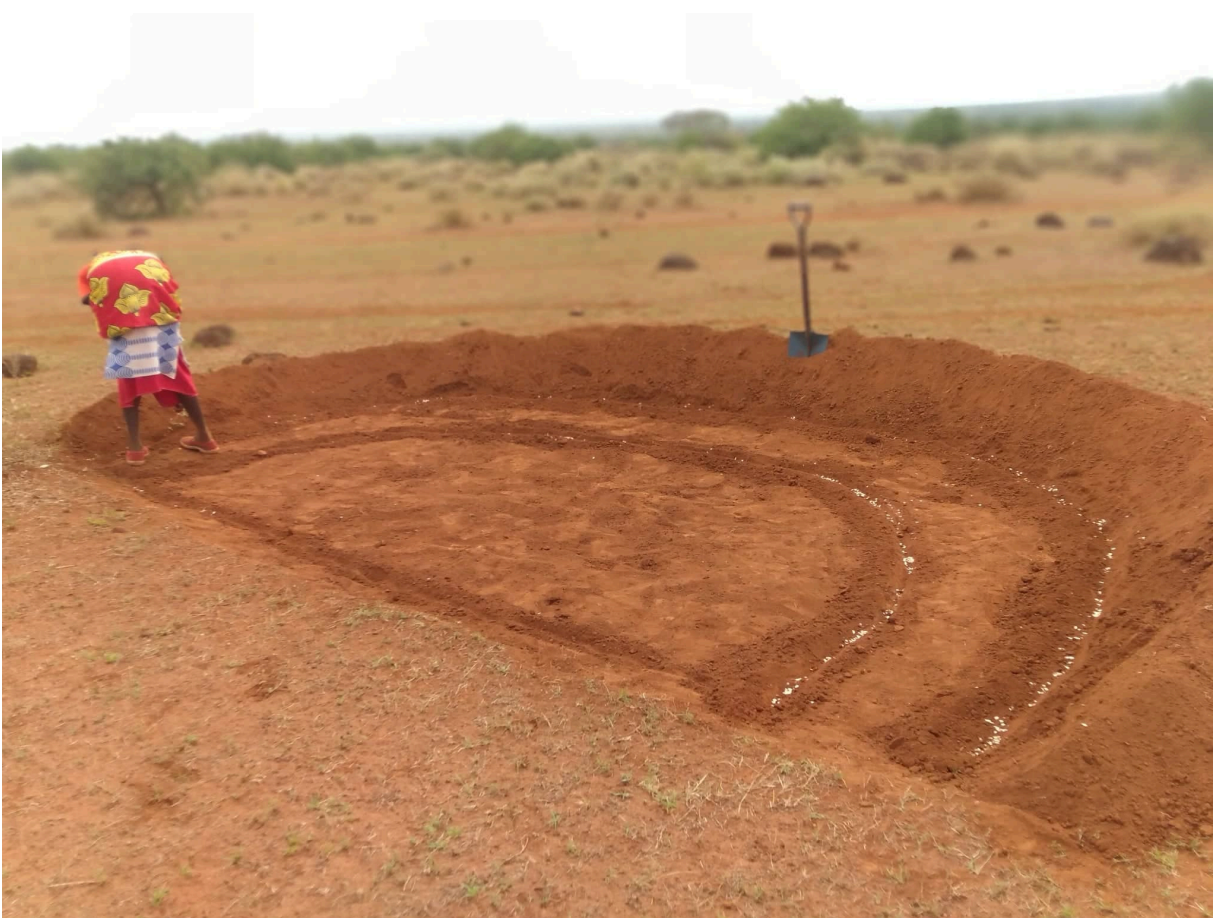
Figure 5: Seeded bund in Ilchalai

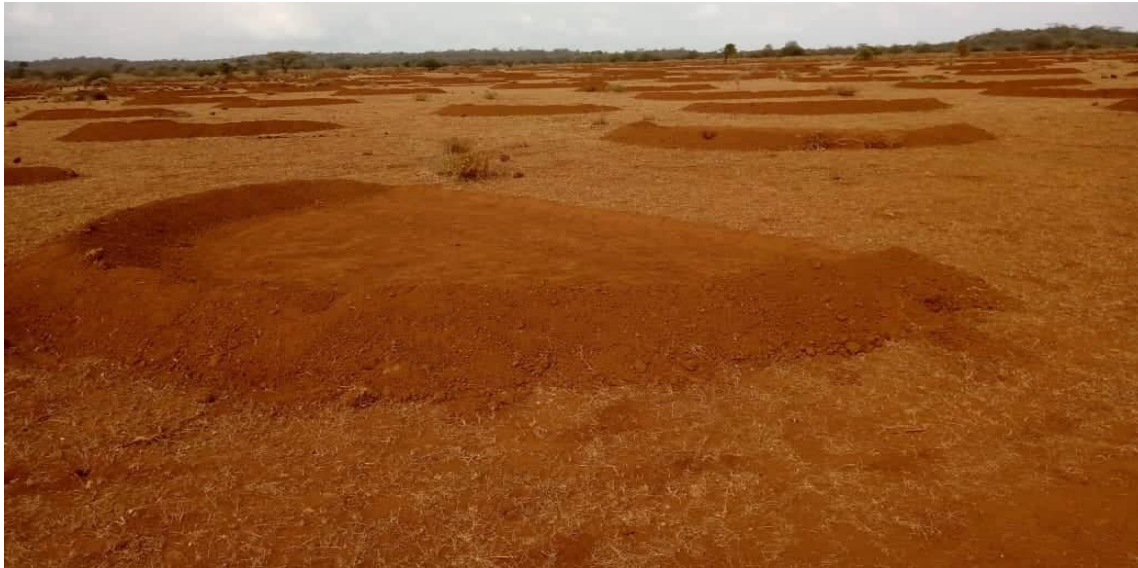
Figure 7: Bunds dug in Ilchalai

In total 42,220 bunds have been dug in this reporting period. As a result of varying weather patterns due to climate change, we are experiencing prolonged droughts in some parts, and very little rains in most parts of Kuku Group Ranch. Ilchalai, has fallen victim to reduced rainfall this season and the site has not received good rains. In May (last rainy season), when we had approximately 30,000 bunds on the ground, there were light showers of rain. Some of the bunds managed to get water, and there was very little growth in the bunds at that point. Important to note, there is already little vegetation growth in the bunds, in comparison to outside the bunds. We are however expecting the OND rains (October, November, December) to be above average. If so, it will allow the bunds to collect enough water for better vegetation growth.

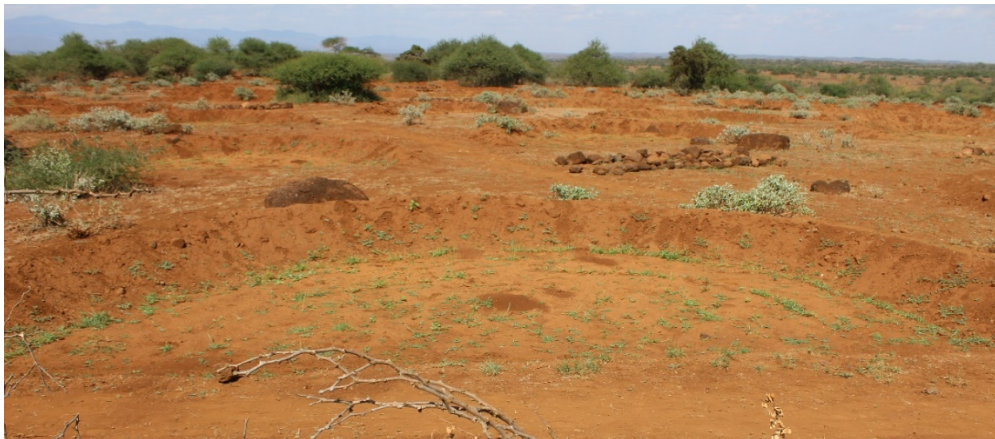
Figure 7: State of Ilchalai bunds after the below average April/May rains.
